**Vermiculite Northwest Removal Site Evaluation**  
**Trip Report**  
**Spokane, Washington**  
**TDD: 01-07-0014**

SUBJ: Vermiculite Northwest Removal Site Evaluation Trip Report

Technical Direction Document (TDD) No. 01-17-0014

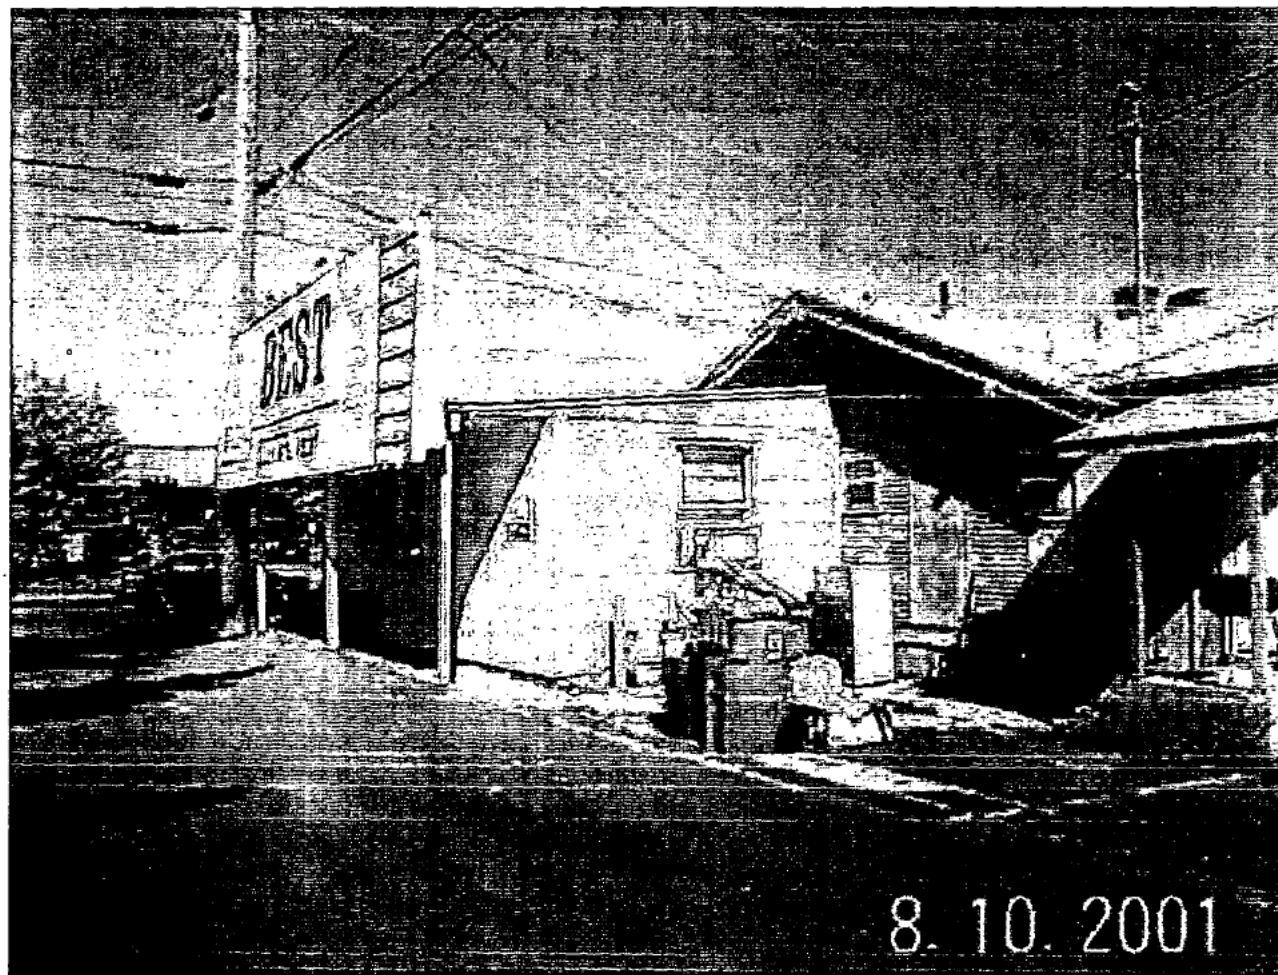
Photo	Date	Time	By	Direction	Description
1.01	8/10/01	1043	HZ	NW	Best Computer; Building 1, Block 23.
1.02	8/10/01	1044	HZ	E	Building 2, Block 23.
1.03	8/10/01	1110	HZ	SE	Buildings 3 to 6, Block 23.

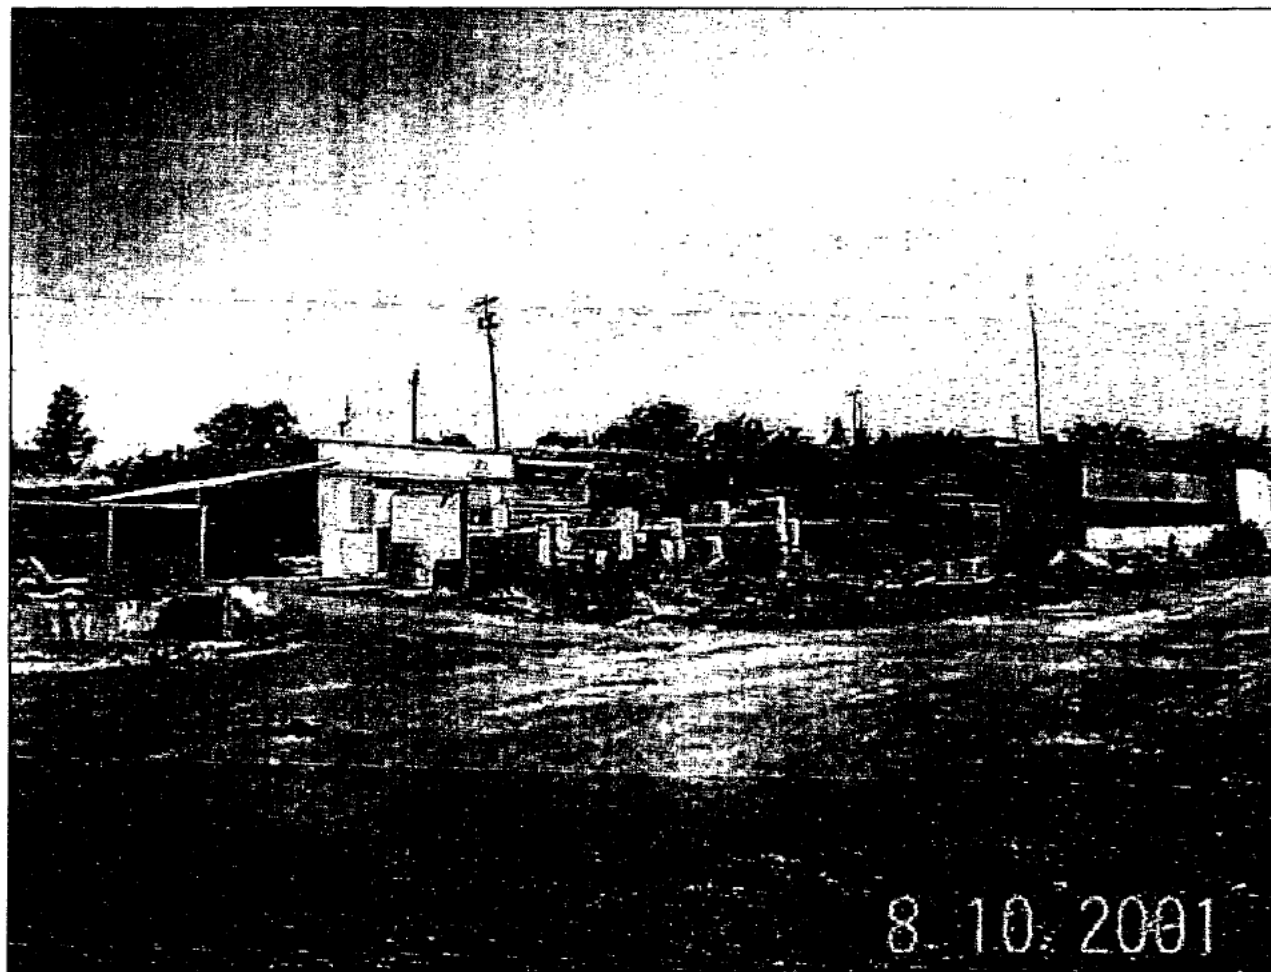
1.04	8/10/01	1111	HZ	NE	Buildings 3 and 5, Block 26. The rail bed is located south of Building 5 (Figure 2).
1.05	8/10/01	1112	HZ	NE	Sinto Street extends east to west across the Vermiculite Northwest property.

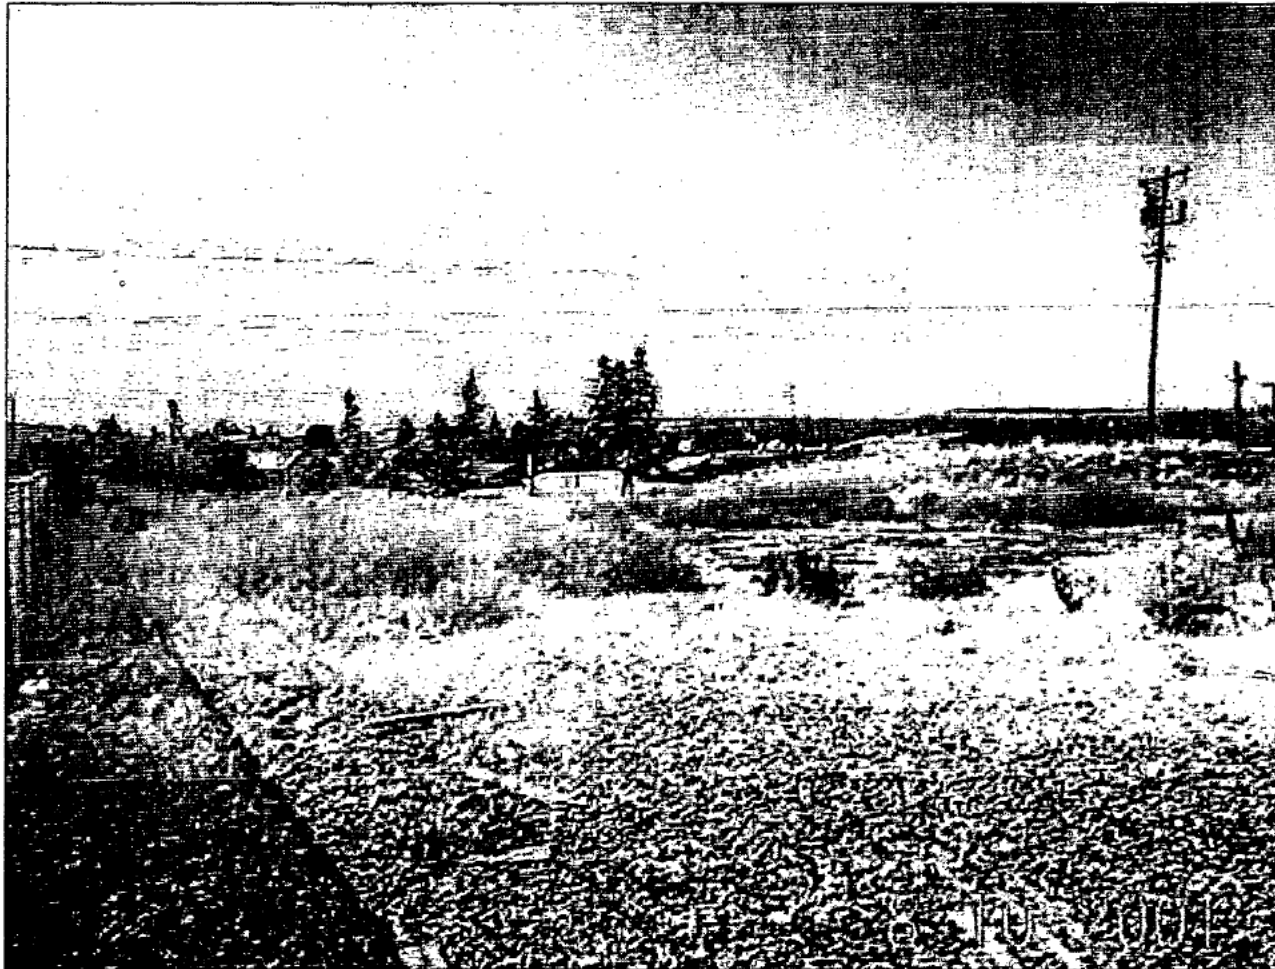
1.06	8/10/01	1120	HZ	N	Building 2, Block 26.
1.07	8/10/01	1121	HZ	W	Northwest bluff.
1.08	8/10/01	1130	HZ	W	Rail bed located south of Building 5, Block 26.

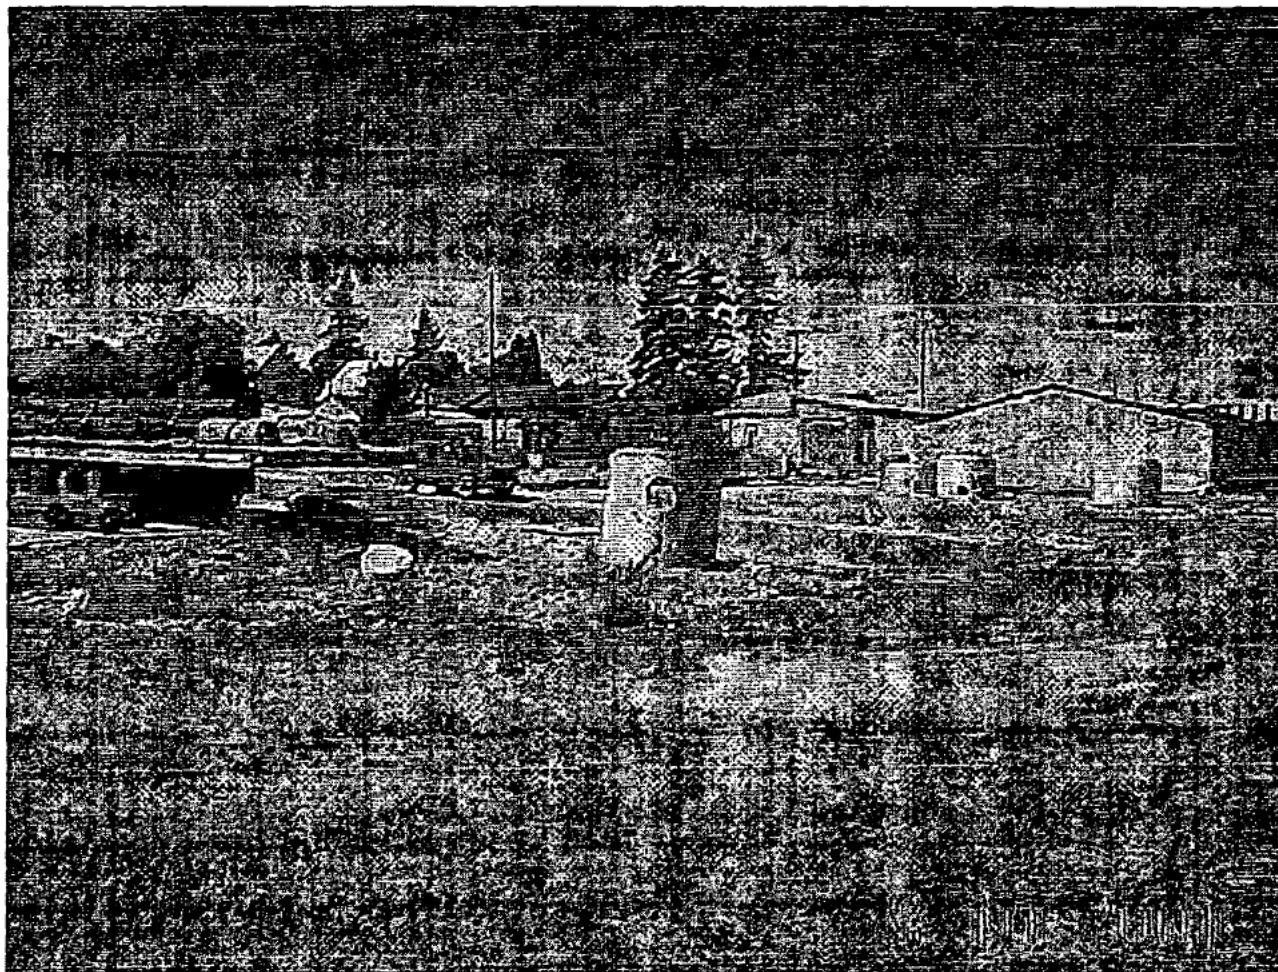
1.09	8/10/01	1135	HZ	SW	The intersection of Sinto and Walnut streets.
1.10	8/10/01	1140	HZ	NE	Northeast bluff.
1.11	8/10/01	1145	HZ	SW	The southwest area of the site.

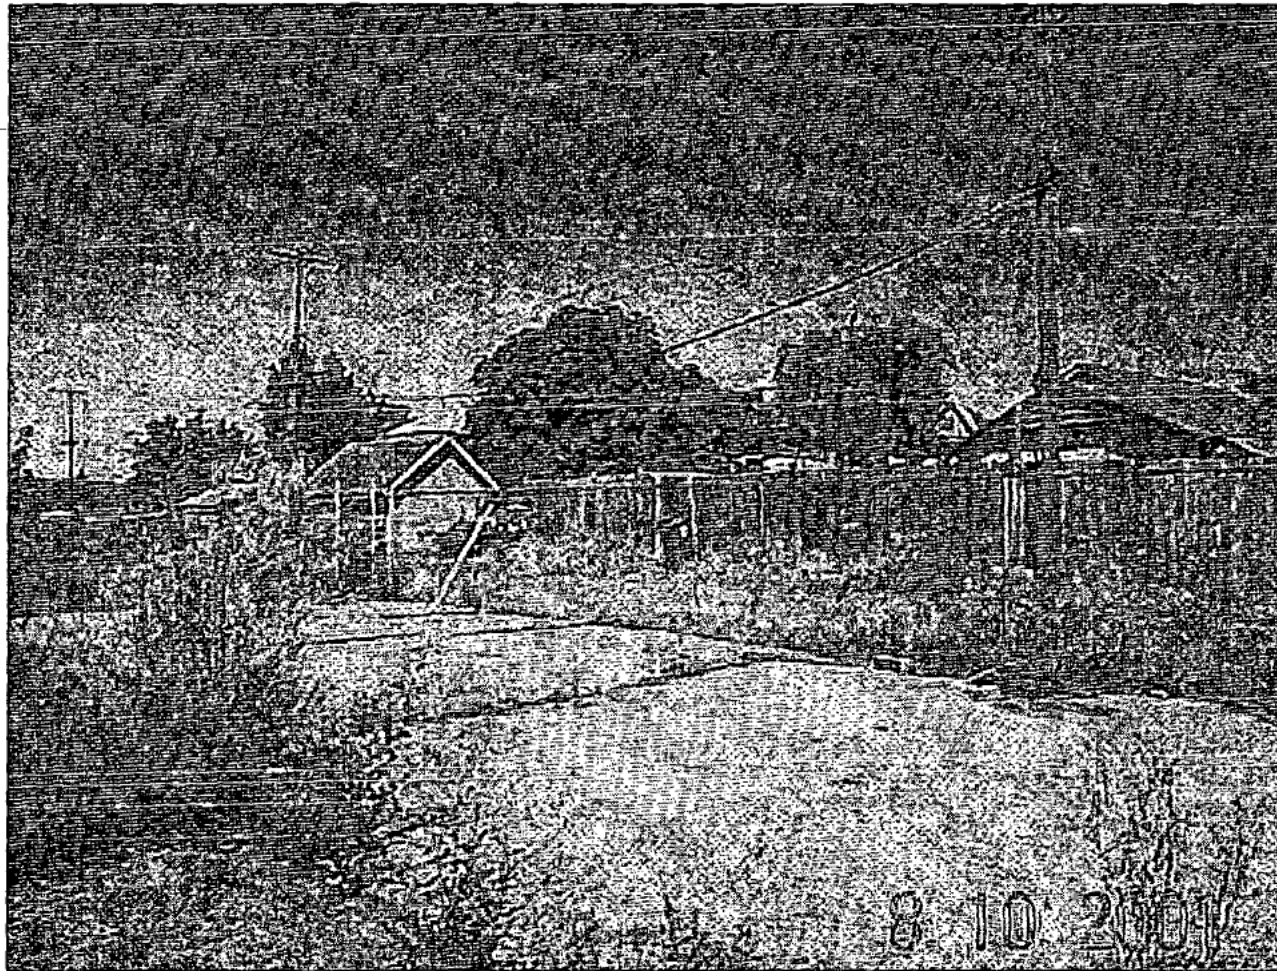
1.15	8/10/01	1146	HZ	NW	Residential homes located north of the site.
1.16	8/10/01	1147	HZ	N	The northeast bluff and Buildings 1 and 2, Block 25.
1.17	8/10/01	1148	HZ	W	North side of Building 1, Block 24.
